OF THE HARMAN, W.VA. QUADRANGLE

by
Roger E. Thomas and Robert J. Hackman
1980

U.S. Geological Survey

OPEN FILE MAP 80-194 (H-4)

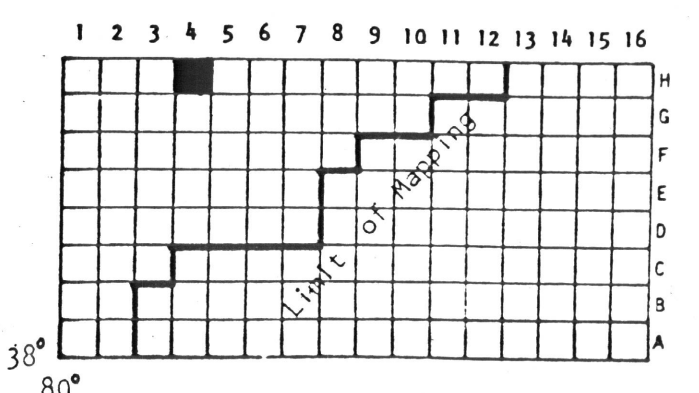
The first five digits of the open file number designate the specific 1:250,000 scale map sheet of which this quadrangle is a part. The last two digits designate the position of the quadrangle in a subdivision of the 1:250,000 scale map based on rows and tiers shown in the diagram to the right. The location of this quadrangle is shown by the black square.
